Application of the 10 Keys Checklist and Partial Extraction Techniques to Optimize Esthetic Outcomes for Adjacent Implants in the Esthetic Zone

Int J Periodontics Restorative Dent 2025;45:317–327. doi: 10.11607/prd.7079

Keywords: dental implants, esthetics, immediate dental implant loading, socket shield technique

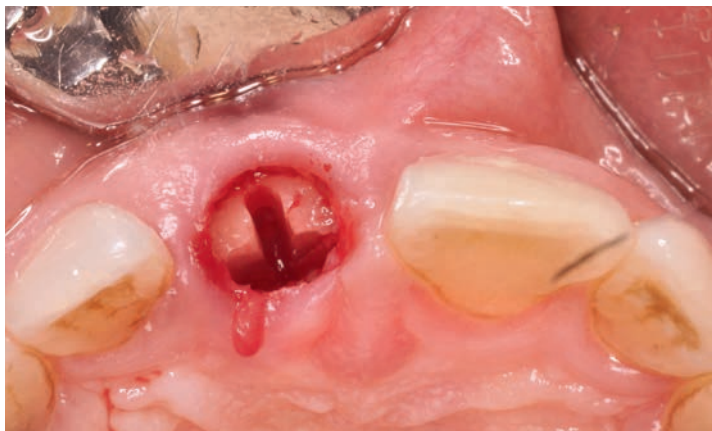
◀ **Fig 2** The tooth root was sectioned into pieces to facilitate minimally traumatic extraction.

One hour before the surgical procedure, the patient was orally premedicated with 2 g amoxicillin and 2 mg lorazepam. Local anesthesia was obtained with articaine with epinephrine 1:200,000. The loose segment of the tooth (tooth 11) was detached using a periosteal elevator and saved. The root was divided lengthwise with a fissure bur and extracted in pieces, avoiding damage to the buccal plate (Fig 2).

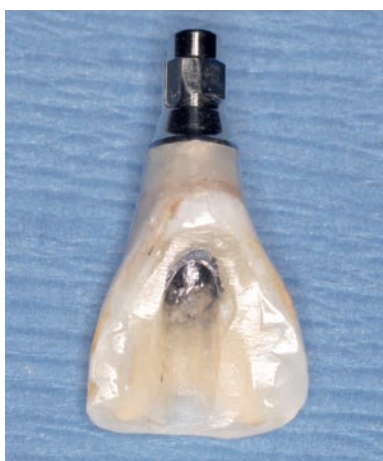
▲ **Fig 4** The provisional restoration finished extraorally with correct contours to promote gingival healing.

The tooth crown was then hollowed, etched, and luted to a titanium temporary cylinder and converted into a screw-retained provisional. The tooth shape, shade, and characterization were preserved. The provisional was then finished in the dental laboratory and polished (Fig 4).

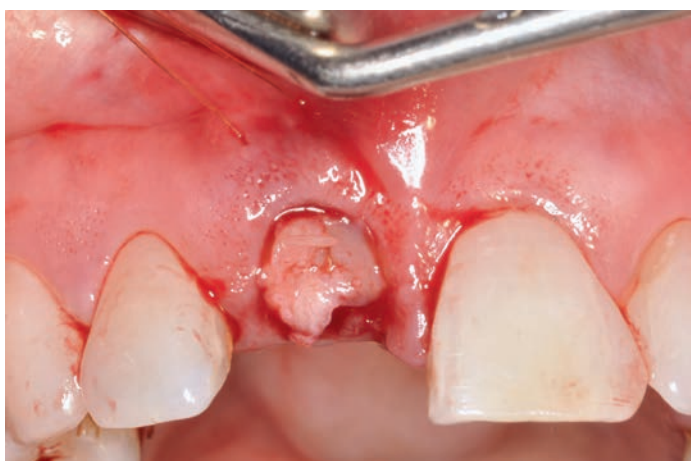
▲ **Fig 5** A connective tissue graft was inserted into the prepared site using a resorbable purse string suture to both guide the graft into position and secure it apically.

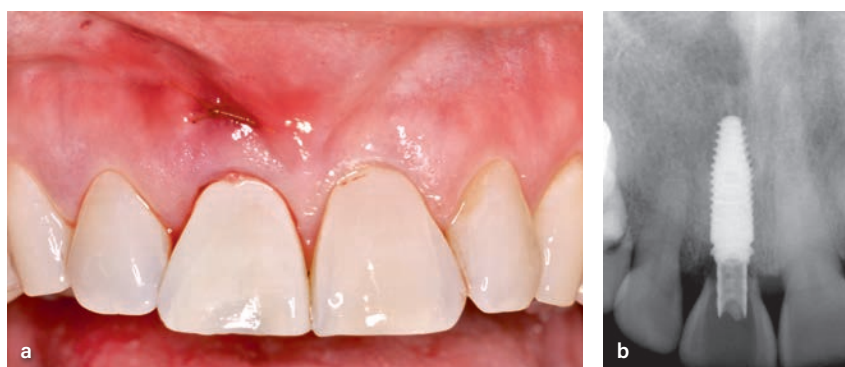
► **Fig 6** (a) Immediate postoperative view showing how the original tooth was converted to a screw-retained provisional with coronal positioning of the labial tissue to overcorrect the pretreatment recession. (b) Immediate postoperative radiograph.

A subepithelial connective tissue graft was harvested from the right palate ($5 \times 7 \times 1.5$ mm). The donor site was sutured with 4-0 chromic gut sutures. A labial intrasulcular incision was directed apically, creating a pouch to place the graft; the graft was secured with a suture (Fig 5). The provisional was placed onto the implant and hand tightened. The access hole was sealed with PTFE and composite. Occlusion was adjusted to confirm no contact in centric or protrusive movements. A radiograph was taken to confirm seating (Fig 6).

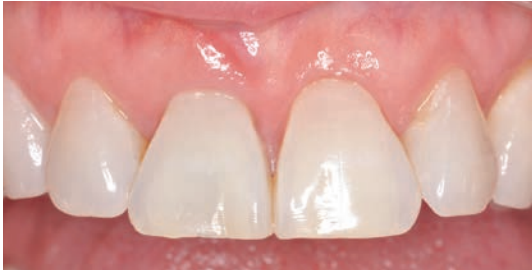
▲ **Fig 7** The final restoration was placed on the implant prior to the gingivectomy. Note that the long interdental papilla between the central incisors has been maintained.

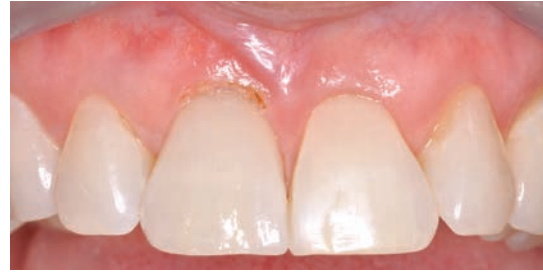
▲ **Fig 8** A laser gingivectomy was performed to create an equal gingival margin height and clinical crown length of the central incisors.

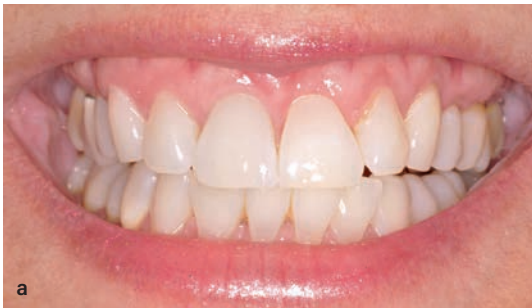
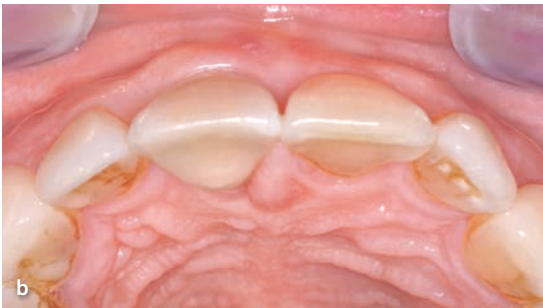
▲ **Fig 9** (a) After healing from the laser gingivectomy, the patient's full smile shows significant gingival display, excellent symmetry of central incisors, and maintenance of gingival contours. (b) Occlusal view of anterior teeth showing slight overcorrection of the root eminence on the implant compared to the left central incisor.

The patient was referred to her restorative dentist for refining by adding composite resin on the provisional, but the facial gingiva was too fibrotic to contour with restorative pressure. The dentist was advised to finish the restoration with current contours (Fig 7) and then to send the patient back for laser gingival contouring (Fig 8). After healing, the patient was pleased with the esthetics and had difficulty distinguishing between her natural tooth and restoration. Preexisting recession was also corrected (Fig 9a). Occlusally, the root eminence of the tooth was slightly increased compared to the left central incisor (Fig 9b).

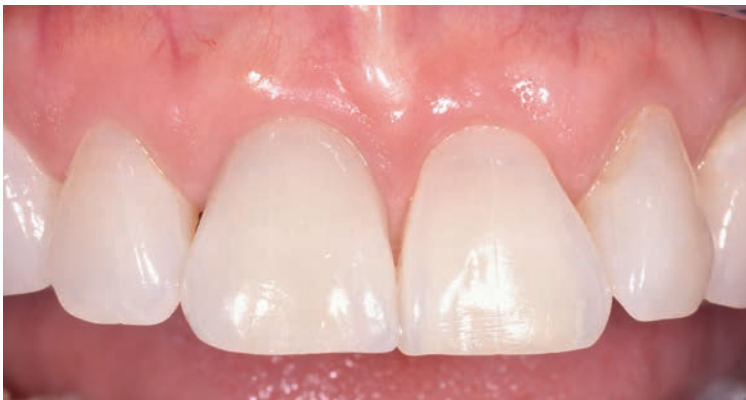
▲ **Fig 10** Clinical view at 5 years showing maintenance of gingival contours and the long interdental papilla.

After 5 years, the patient was recalled to assess the stability of the results, and she reported that she was very pleased. Tissue levels, color, papilla height, and volume appeared stable (Fig 10).

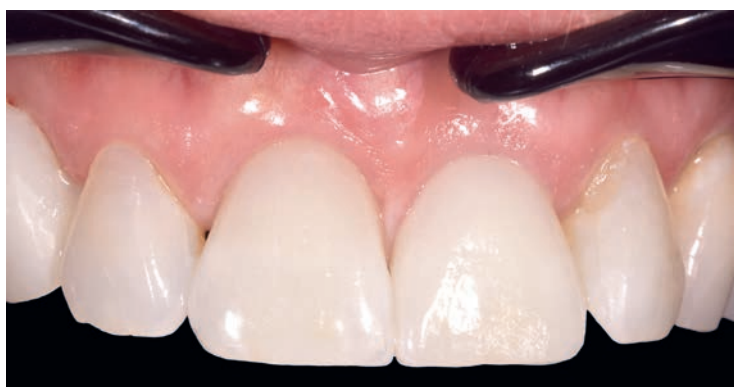
► **Fig 16** Two-year postoperative clinical view with a new final restoration on the left central incisor and the original crown replaced on the right central incisor. The interdental papilla is in exactly the same position as pretreatment photos, and labial gingival margin symmetry was maintained.

remodeling, gingival inflammation, or recession. At 2 years postsurgery, the interimplant papilla had maintained its original dimension, and the patient was satisfied with the esthetic outcome (Fig 16). On both restorations, a pink esthetic score of 14 was obtained, which indicates excellent esthetic results.²
